**Flood Control Project Maintenance**  
**2014 Structure Summary Report**  
**Overall Unit and Item Ratings**

**Madera County FCWCA**

**Ash And Berenda Slough Control Structures**

**Flood Control Project Maintenance**  
**Unit Cover Sheet**  
**2014 Structure Inspection Results**

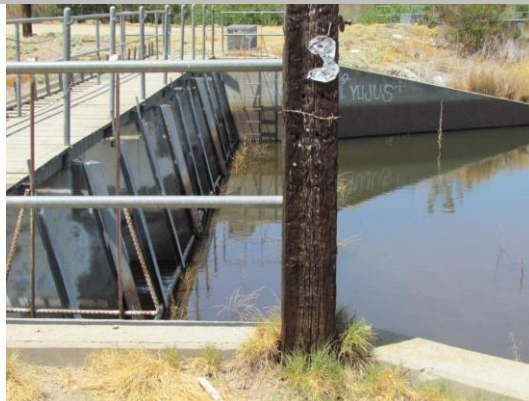
Photo 1 of 4 : ST\_2014\_NA0011\_46\_1\_20140819\_00007.jpg

Berenda Slough Control Structure view of upstream side of structure.

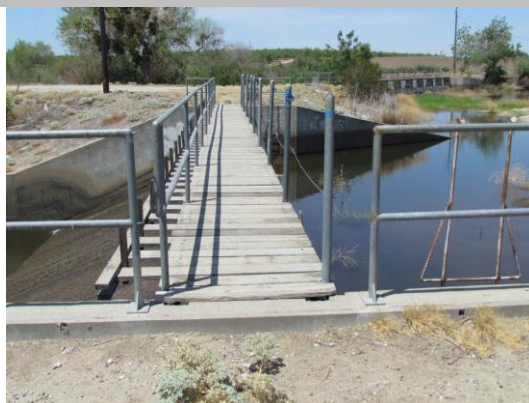
Photo 2 of 4 : ST\_2014\_NA0011\_46\_1\_20140819\_00008.jpg

Berenda Slough View of Structure gangway and safety rails.

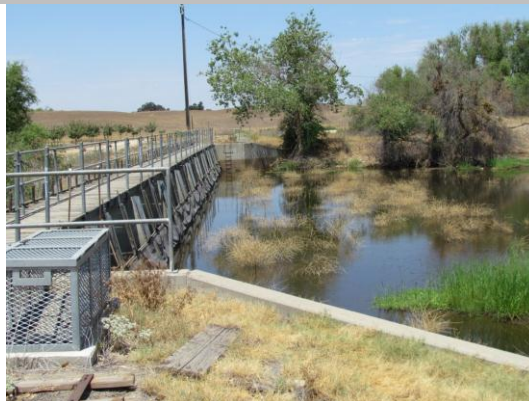
Photo 3 of 4 : ST\_2014\_NA0011\_46\_1\_20140819\_00009.jpg

Ash Slough Diversion Structure from upstream side.

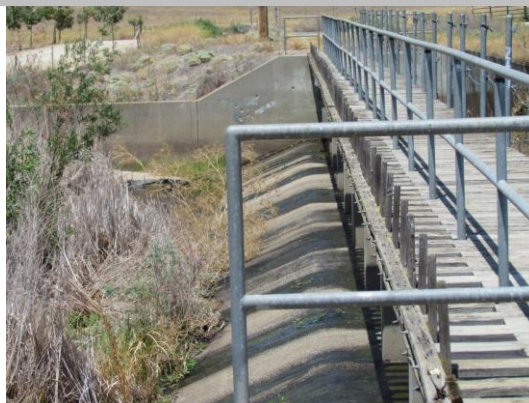
Photo 4 of 4 : ST\_2014\_NA0011\_46\_1\_20140819\_00010.jpg

Berenda Slough Control Structure looking downstream.

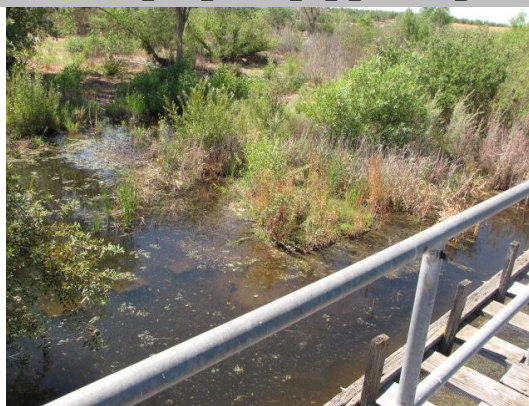
Photo 1 of 2 : ST\_2014\_NA0011\_46\_2\_20140707\_00005.jpg

LM Start	0.00	Rating **	M	Issue No.	2	
LM End	0.00	Issue Type +	Ma	Location *		
Category	Structures & Concrete Lined Channels			GPS Latitude/Longitude		
				Start	End	
Item	Vegetation & Obstructions			37.157904 °	37.143520 °	
				-120.124165 °	-120.162171 °	
DWR ID	DWR_NA0011_46_t_2012_2					
Action/Comments						
Inspector Comments: No vegetation on the upstream side of Berenda

Ash Slough vegetation present at downstream of the structure. Photo taken 7-17-13.

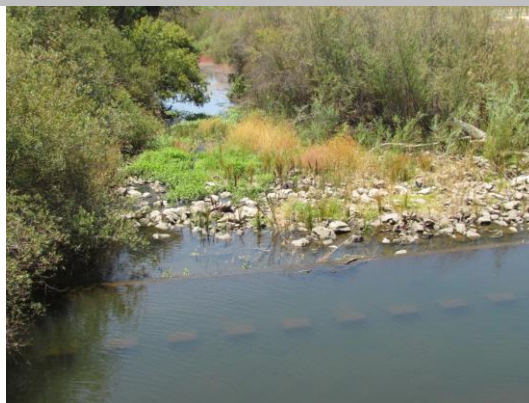
Photo 2 of 2 : ST\_2014\_NA0011\_46\_2\_20140819\_00011.jpg

LM Start	0.00	Rating **	M	Issue No.	2 (cont)	
LM End	0.00	Issue Type +	Ma	Location *		
Category	Structures & Concrete Lined Channels			GPS Latitude/Longitude		
				Start		End
Item	Vegetation & Obstructions			37.157904 °		37.143520 °
				-120.124165 °		-120.162171 °
DWR ID	DWR_NA0011_46_t_2012_2					
Action/Comments						
Inspector Comments: No vegetation on the upstream side of Berenda Slough Control Structure. Downstream has wild growth of trees and other vegetation growth.

Ash Slough vegetation present downstream of the structure.

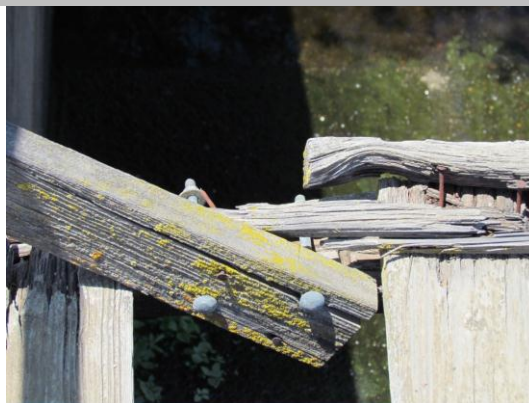
Photo 1 of 1 : ST\_2014\_NA0011\_46\_23\_20140819\_00012.jpg

LM Start	0.00	Rating **	M	Issue No.	23	
LM End	0.00	Issue Type +	Ma	Location *		
Category	Structures & Concrete Lined Channels			GPS Latitude/Longitude		
				Start		End
Item	Safety			37.157904 °		37.143520 °
				-120.124165 °		-120.162171 °
DWR ID	DWR_NA0011_46_t_2012_23					
Action/Comments						
Inspector Comments: Minor safety hazards are present, but do not pose an immediate threat to the structure or personnel at the structure. Corrections should be made prior to the next annual inspection. The damages reported in the last inspection hasn't been corrected to date.

Damaged timbers on downstream side of Ash Slough Structure's gang way have not been replaced.

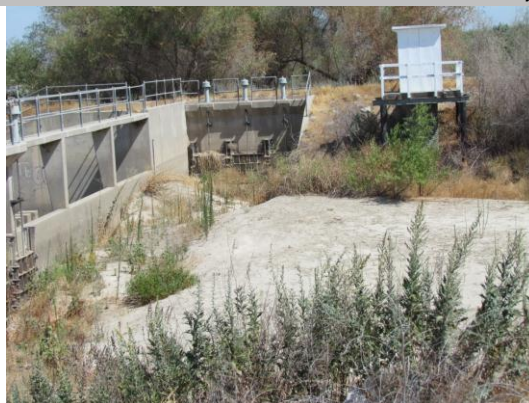
Photo 1 of 1 : ST\_2014\_NA0011\_6\_1\_20140818\_00005.jpg

Fresno River Diversion Weir viewed from left bank. No water in channel but there is vegetation present in channel.

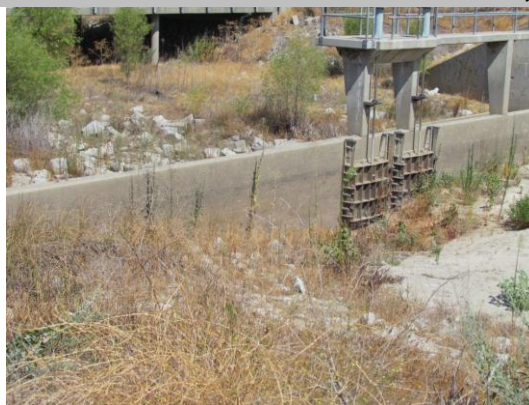
Photo 1 of 2 : ST\_2014\_NA0011\_6\_2\_20140818\_00006.jpg

LM Start	0.00	Rating **	M	Issue No.	2	
LM End	0.00	Issue Type +	Ma	Location *		
Category	Structures & Concrete Lined Channels			GPS Latitude/Longitude		
				Start	End	
Item	Vegetation & Obstructions			36.967930 °	36.967930 °	
				-120.255680 °	-120.255680 °	
DWR ID	DWR_NA0011_6_t _ 2012_2					
Action/Comments						
Inspector Comments: There is a build up of vegetation on the downstream side of the deflectors within the channel of the Fresno River and on the left bank (unit 6) there is buildup of veg. growth inside the security fence area on the bank.

Viewed from left bank vegetation upstream side of the spill way.

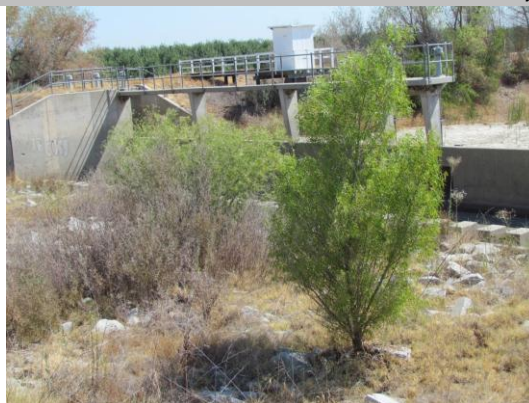
Photo 2 of 2 : ST\_2014\_NA0011\_6\_2\_20140818\_00007.jpg

LM Start	0.00	Rating **	M	Issue No.	2 (cont)	
LM End	0.00	Issue Type +	Ma	Location *		
Category	Structures & Concrete Lined Channels			GPS Latitude/Longitude		
				Start		End
Item	Vegetation & Obstructions			36.967930 °		36.967930 °
				-120.255680 °		-120.255680 °
DWR ID	DWR_NA0011_6_t_2012_2					
Action/Comments						
Inspector Comments: There is a build up of vegetation on the downstream side of the deflectors within the channel of the Fresno River and on the left bank (unit 6) there is buildup of veg. growth inside the security fence area on the bank.

Vegetation present downstream side of spillway, willow trees and other wild plant growth.

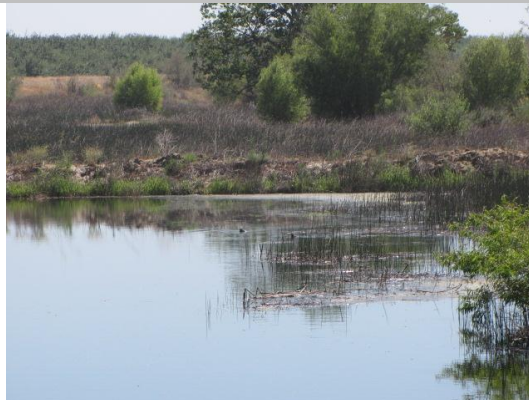
Photo 1 of 2 : ST\_2014\_NA0011\_6\_6\_20140707\_00003.jpg

LM Start	0.00	Rating **	U	Issue No.	6
LM End	0.00	Issue Type +	Ma	Location *	
Category	Structures & Concrete Lined Channels	GPS Latitude/Longitude			
		Start	End		
Item	Encroachments	36.967930 °		36.967930 °	
		-120.255680 °		-120.255680 °	
DWR ID	DWR_NA0011_6_t_2012_6				
Action/Comments					
Inspector Comments: This earthen dam was placed across Fresno River channel last year 2013 by Chowchilla Water District, at the time of discovery Madera County sent them a letter to have it removed.

This earthen dam has no CVFPB permit. Photo taken 7-17-13.

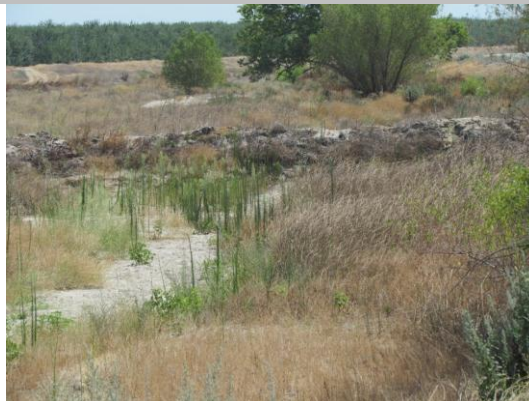
Photo 2 of 2 : ST\_2014\_NA0011\_6\_6\_20140818\_00008.jpg

Unauthorized earthen dam upstream of weir in Fresno River.

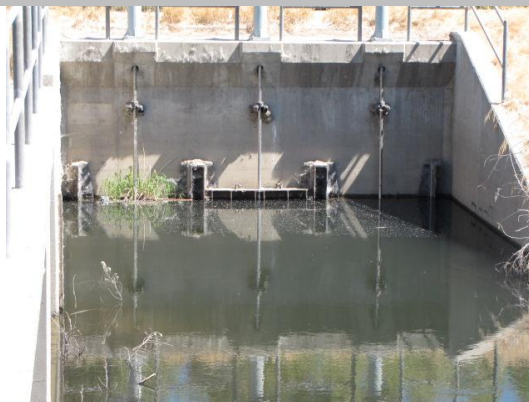
Photo 1 of 1 : ST\_2014\_NA0011\_6\_11\_20140707\_00004.jpg

LM Start	0.00	Rating **	N	Issue No.	11
LM End	0.00	Issue Type +	Ma	Location *	
Category	Structures & Concrete Lined Channels			GPS Latitude/Longitude	
				Start	End
Item	Flap Gates			36.967930 °	36.967930 °
				-120.255680 °	-120.255680 °
DWR ID	DWR_NA0011_6_t_2012_11				
Action/Comments					
Inspector Comments: This structure has screw gates instead of flap gates.

This structure has screw gates that were closed during this inspection.  
Photo taken 7-17-13.
